Table Rock Lake Shell Knob Restaurant - South

Presented as part of an extensive study and works project undertaken from 2001 to 2005 by Table Rock Lake Water Quality

SHELL KNOB RESTAURANT STATS

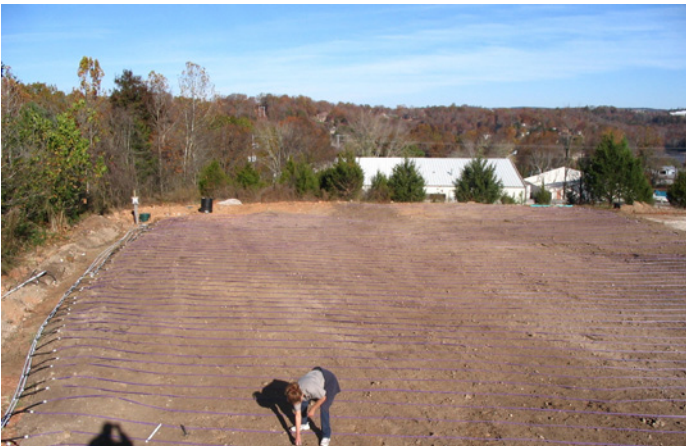
Before bringing soil in to cover the dripperline, a crew member ensures that the rows are equally spaced and held in place with soil staples.

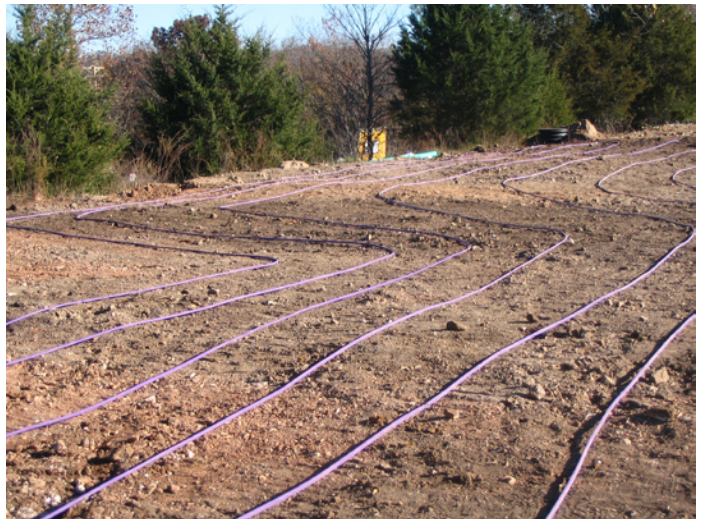
The flexibility of Netafim Bioline is an important feature. It allows the designer to match the dripperline to the shape of the dispersal areas with ease.

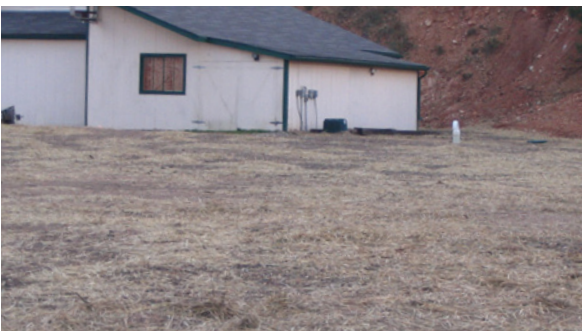
Once the dripperline is covered with soil, grass seed or other cover is broadcast and the field is covered with straw.
